**SAS Superstructure**

Location: 04-SF-80-13.2 / 13.9

Daily Diary Report by Bid Item

Diary #: 861 Const Calendar Day: 386 Date: 25-Jun-2013 Tuesday

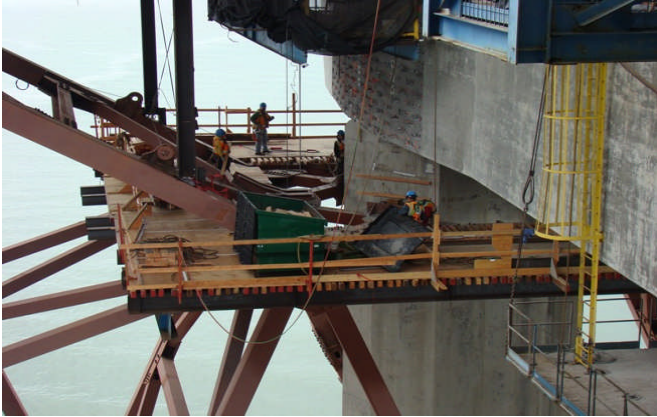
ABF crews preparing to install falsework for the S1 Shear Key bottom slab section.

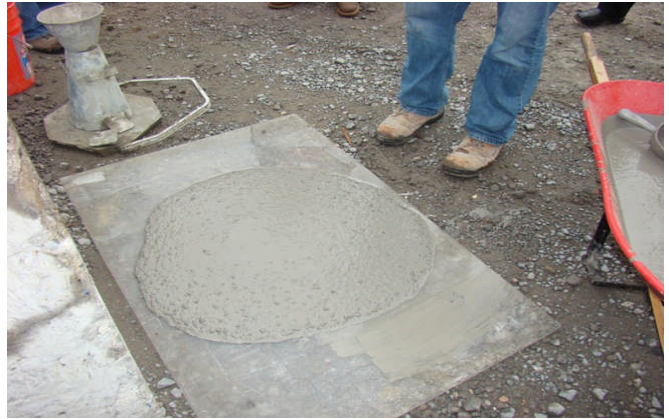
Slump flow of the SCC used for the mockup today with a average diameter of 28.9" and consistent coarse aggregate distribution over the spread.

1.) Concrete trucks arrived approximately around 9:00am with the first truck (#215) beginning to discharge SCC concrete around 9:15am. At this time there was overcast skies with an ambient temperature of 64F and a measured concrete temperature of 75F. Smith Emery technicians verbally informed me that they were going to make 21 cylinders testing for the compressive strength of the SCC. I inquired about the number of cylinders to be tested at certain days, the technicians couldn't provide that information. Slump flow of the SCC was measured at 700mm and 770mm with an average of 735mm. Visual observation of the SCC slump flow was acceptable with coarse aggregate evenly distributed on the glass surface and no appreciable halo(s). The tolerance for this mix design is 700mm +/- 50mm.

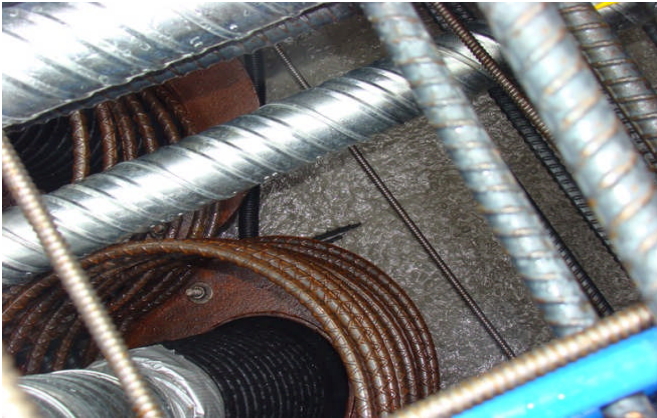
The SCC flowing around PT bearing plates, ducts, rebar, etc which appeared to distribute coarse aggregate (no settling observed) in the mix.

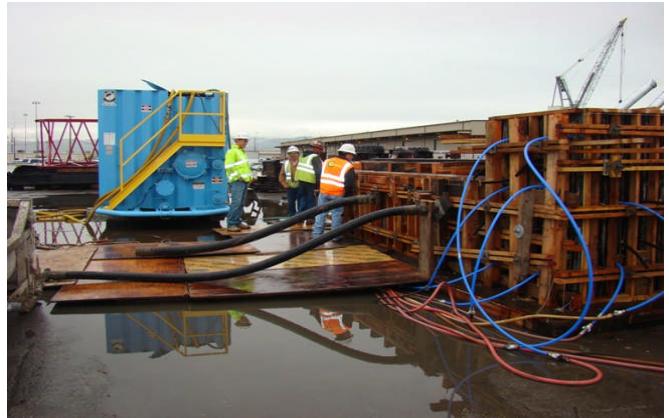
Shear Key modification bottom section mockup in the ABF Burma Road office parking lot and storage yard.

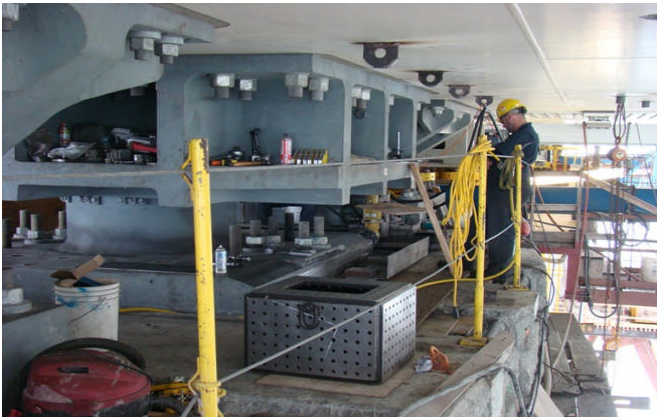
IPMC technicians seen monitoring the milling operation of the S2 Shear Key on the east side of the lower stub section.

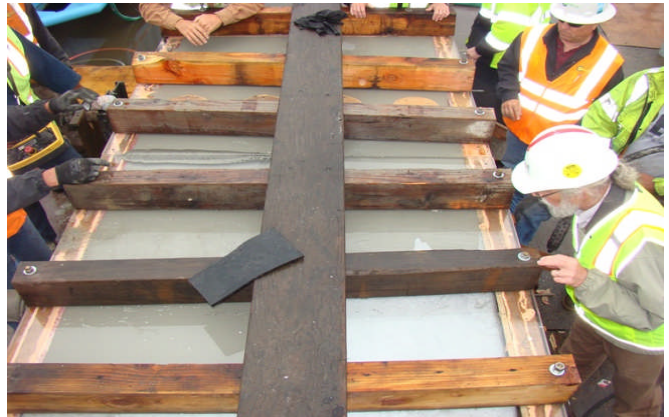
SCC contacting the plexi-glass (bottom of cap beam) while pumping from a side inlet proving the mix can flow well.

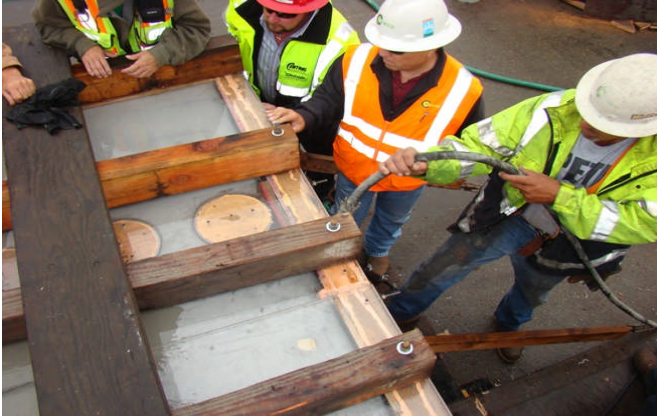
As the SCC got closer to the plexi glass a vibrator was used to "sting" the concrete to stimulate flow and consolidation.

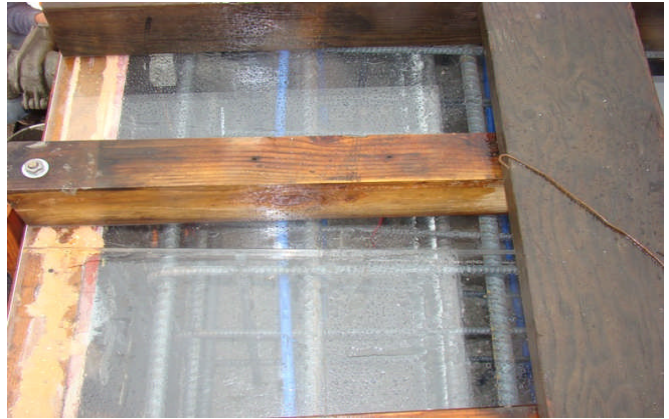
SCC seen flowing in the bottom section (concrete under the cap) to test the flow to ensure that the concrete is fully consolidated.
